User Safety Notice Latchways Standard Self-Retracting Lifeline

January 4, 2021

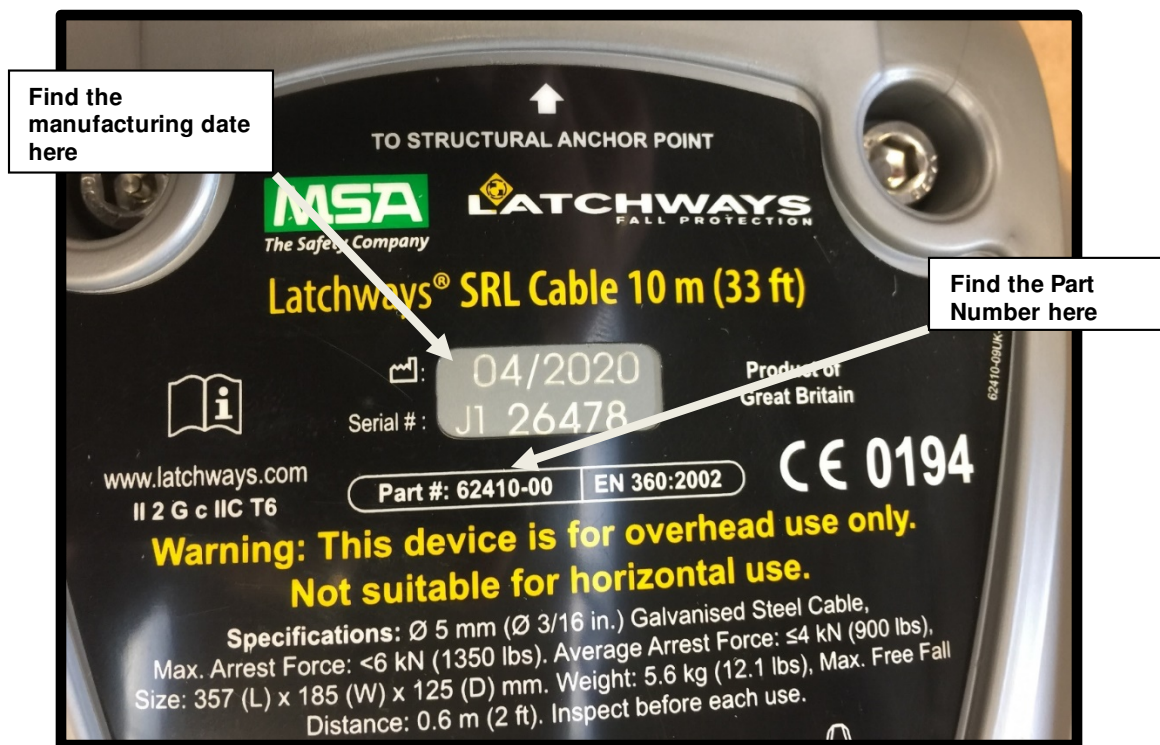
Figure 1 – Part Number and Manufacturing Date Location

- 1) Confirm that the part number is one of those listed in Table 1. Reference Figure 1. If your SRL is **not** one of these part numbers, no further action is needed. If your SRL is one of these part numbers, proceed to step 2.
- 2) Confirm that the manufacturing date marked on the unit is 05/2020, 06/2020, 07/2020, 08/2020, 09/2020, 10/2020, 11/2020 or 12/2020. If the manufacturing date is **not** in this range, no further action is needed. If the manufacturing date is in this range, proceed to step 3.
- 3) Confirm whether a green dot is present next to the service label, or on the box label for an unopened unit. Reference Figure 2. If the green dot is present, the unit has been re-worked by MSA and no further action is needed. If the green dot is not present, follow the instructions below for Addressing Potentially Affected Latchways Standard SRLs.

MSA is advising all customers remove from service and return to MSA for rework any Latchways Standard SRL with a part number shown in Table 1 AND a manufacturing date from 05/2020 to and including 12/2020.
